RESERVE STUDY

Meadow Grove Association

Ann Arbor, Michigan June 14, 2022

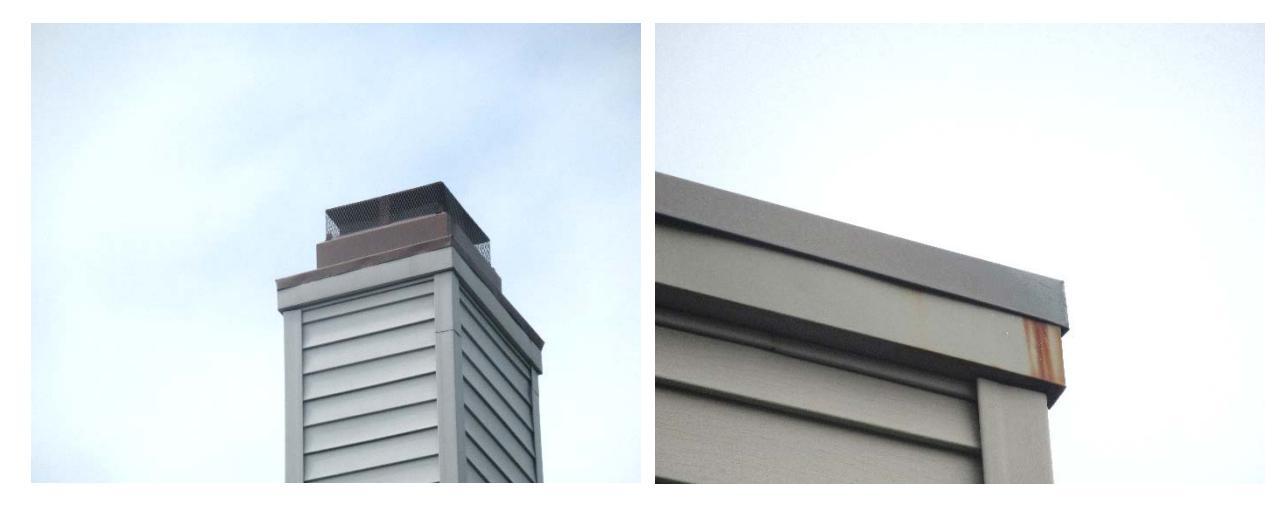
Condition: Good to fair overall with rust evident.

Chimney cap

Rust at chimney cap

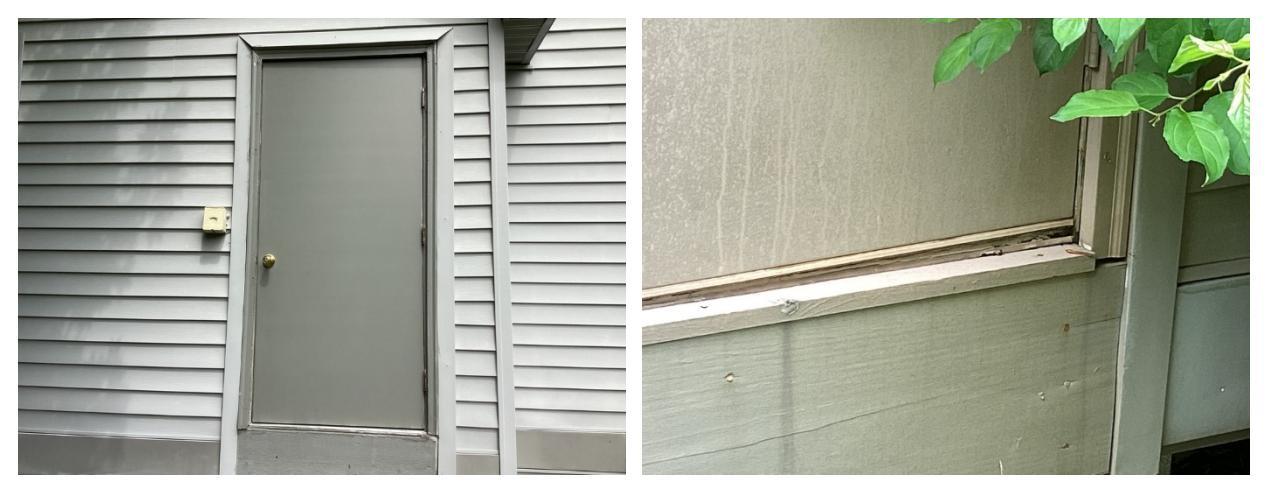
Condition: Good to fair overall. We note deterioration at frame.

Utility door

Frame deterioration

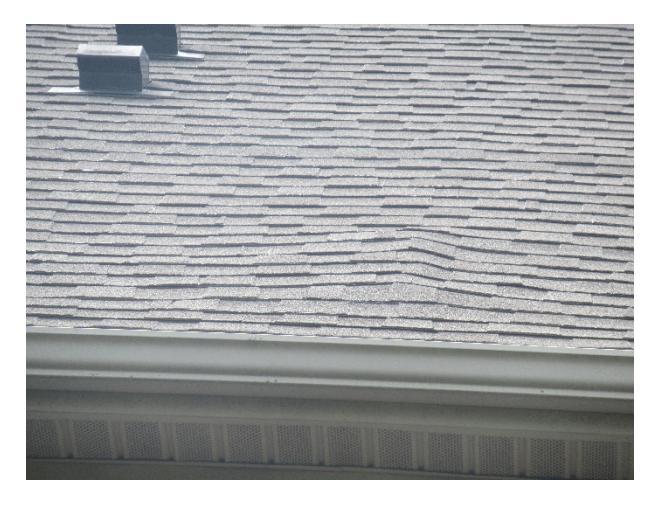
Sheathing deflection

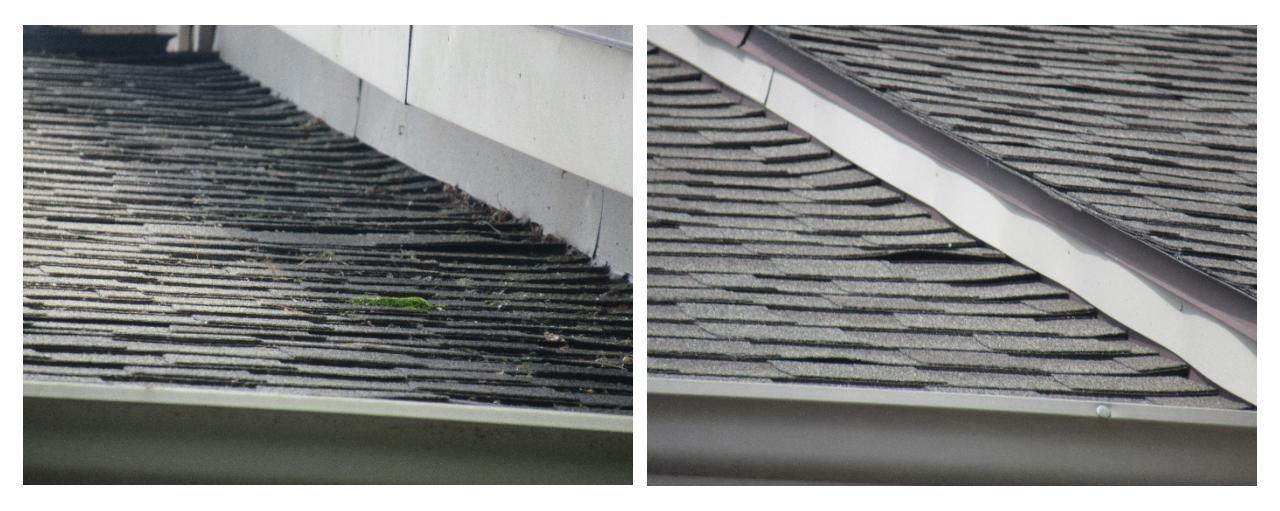
Shingle curl and organic growth

Shingle curl

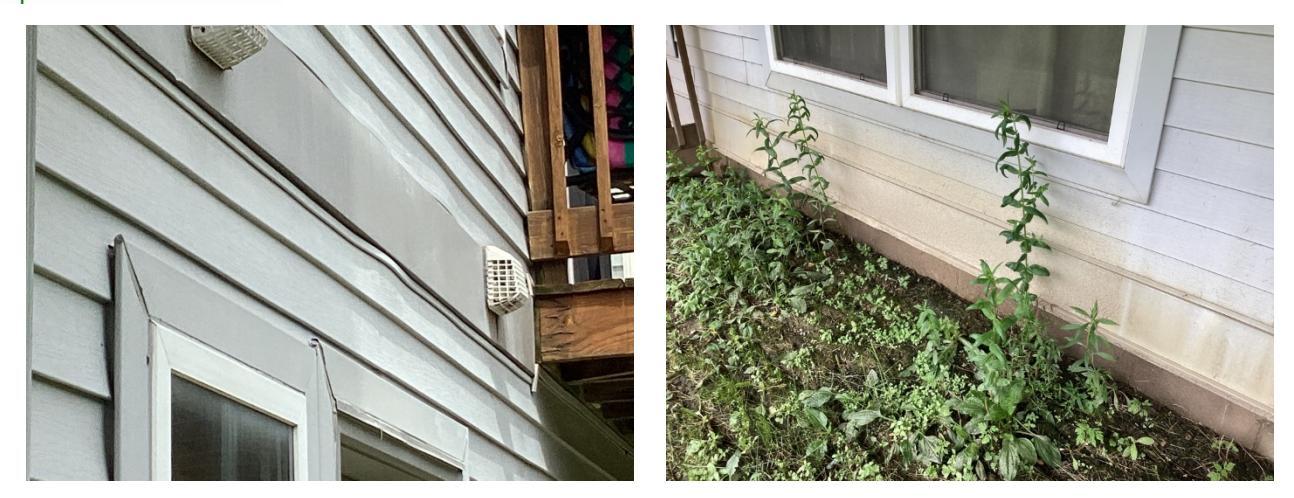
Condition: The siding is reported in good overall condition. We note isolated siding damage, deflection and discoloration. The Board informs us of water leaks due to the lack of building wrap and flashing at the windows and doors. The Association has installed building wraps and flashing, and conducted repairs as needed to a minor portion of the building over the years. The Association installed building wrap and flashing at a portion of two units in 2022, and the remaining buildings in the near-term while re-using the original siding for approximately \$43,000 per building. Based on discussion with the Board, we depict this project beginning by 2023 and concluding by 2027. For the purpose of this Reserve Study, we conservatively include installation of the building wrap and flashing at all units during this five-year project.

Siding deflection

Discoloration

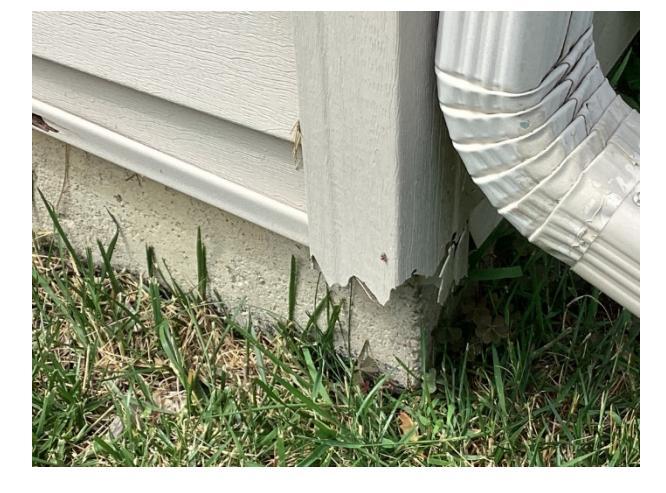
Siding damage

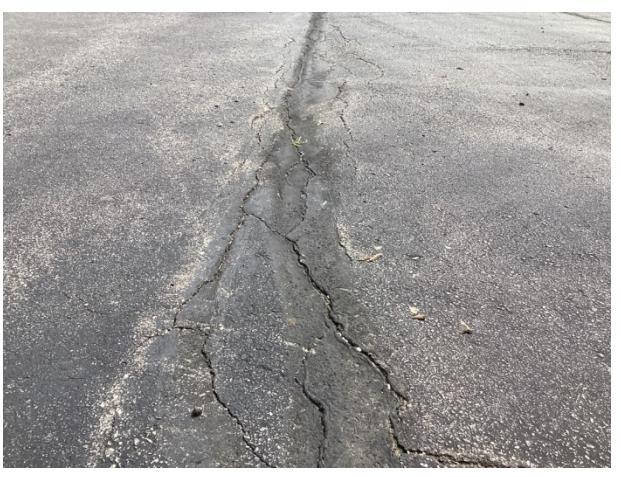
Condition: Fair to poor overall with systemic cracks, patches, standing water, alligator cracks and previous repairs evident. We note a higher frequency of pavement deterioration along Bent Trail Drive.

Pavement cracks along Bent Trail Drive

- Installation of building wrap and flashing at the buildings as proposed by the Board
- Repaying of the asphalt pavement due to evidence of significant deterioration
- Replacement of a portion of the roofs due to age
- Replacement of the timber retaining walls due to evidence of wood deterioration and rot

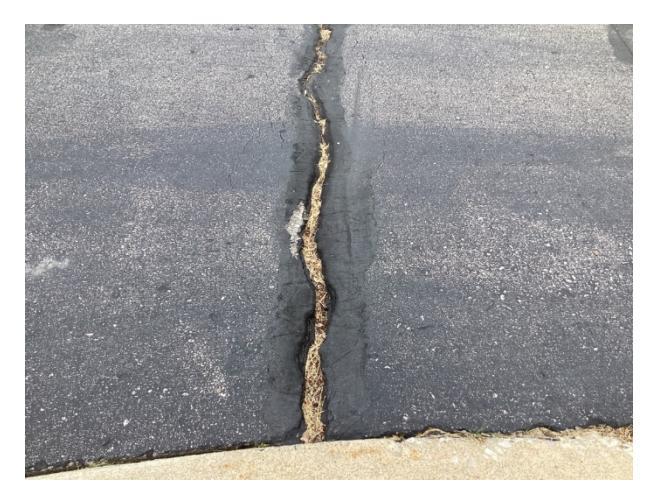
Pavement cracks along Meadow Grove Trail

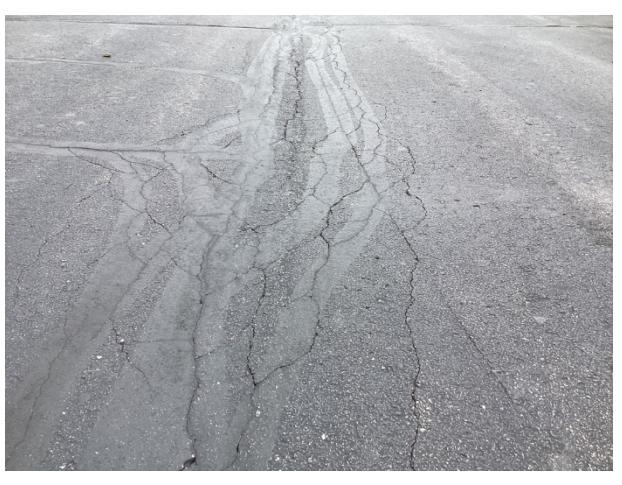
Alligator cracks along Meadow Grove Trail

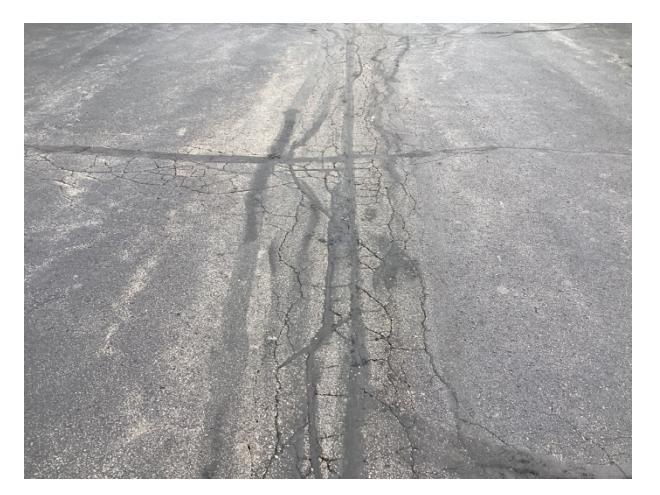
Previous repairs and alligator cracks along Meadow Grove Trail

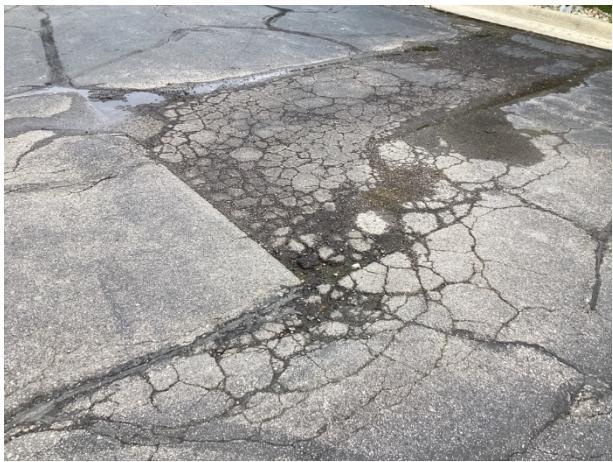
Alligator cracks along Meadow Grove Trail

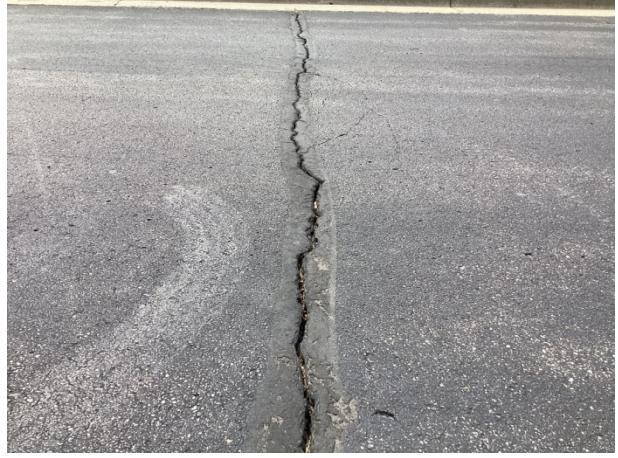
Pavement cracks along Bent Trail Drive

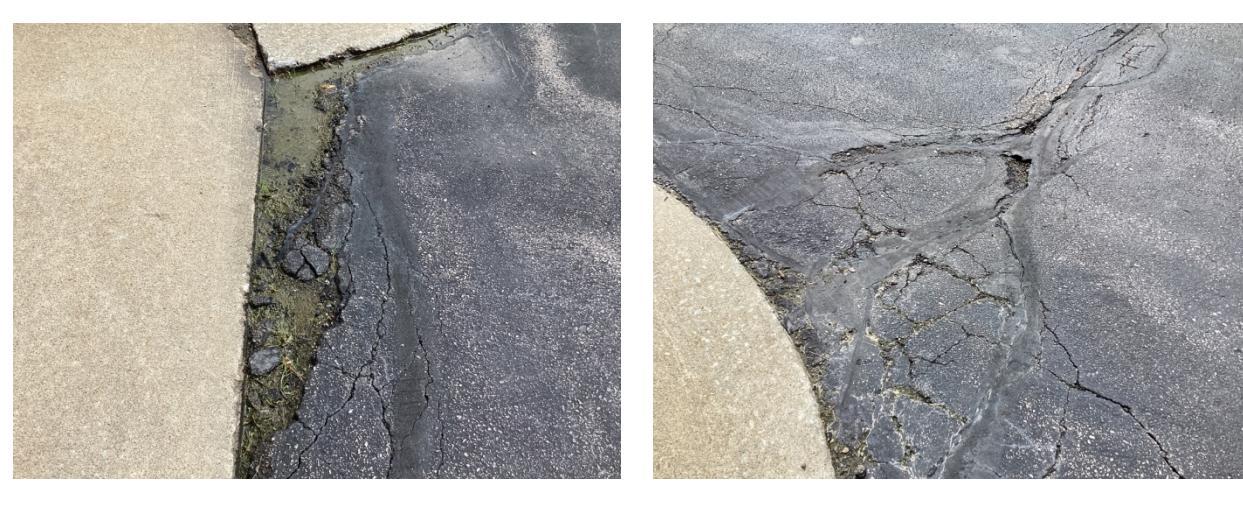
Edge deterioration and pooling of water at Bent Alligator cracks and pavement deterioration along Trail Drive Bent Trail Drive

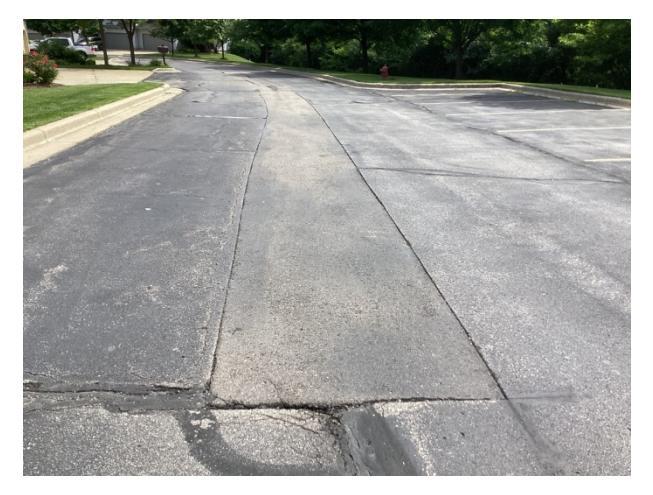
Previously patched section

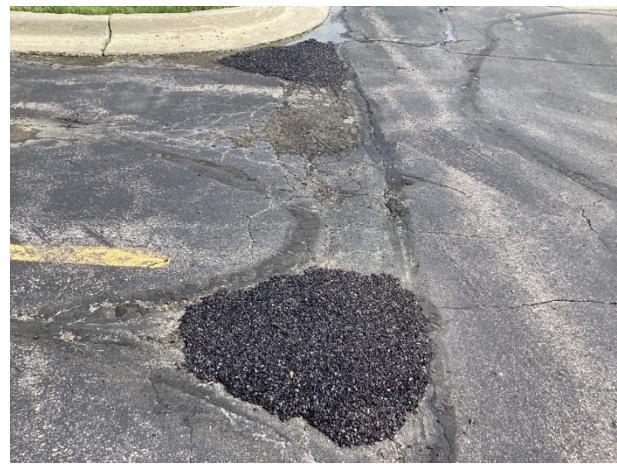
Pavement cracks and previous repairs

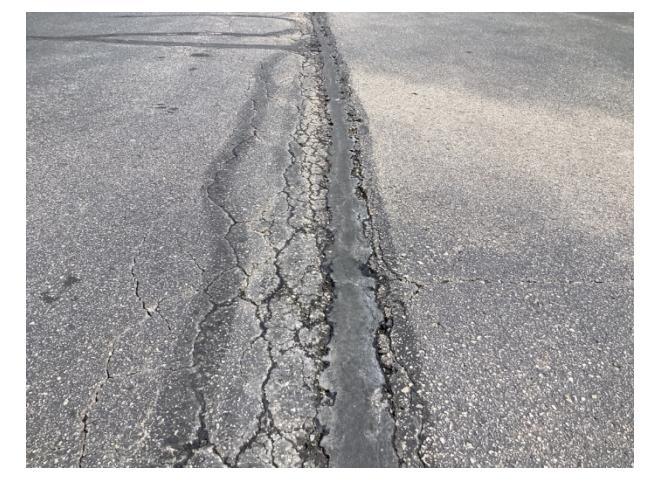
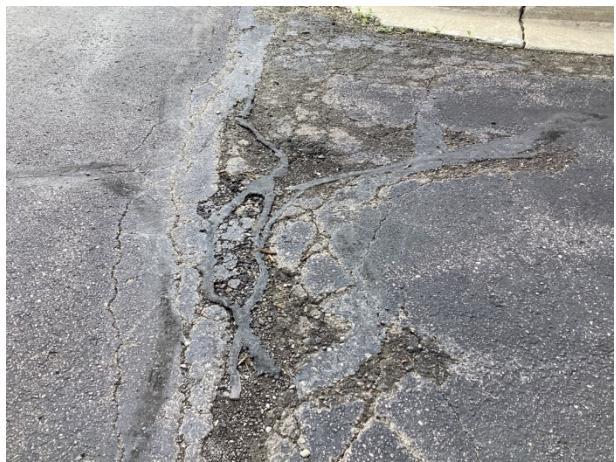
Alligator cracks along failed repairs along Bent Trail Drive

Pavement deterioration and failed repairs along Bent Trail Drive

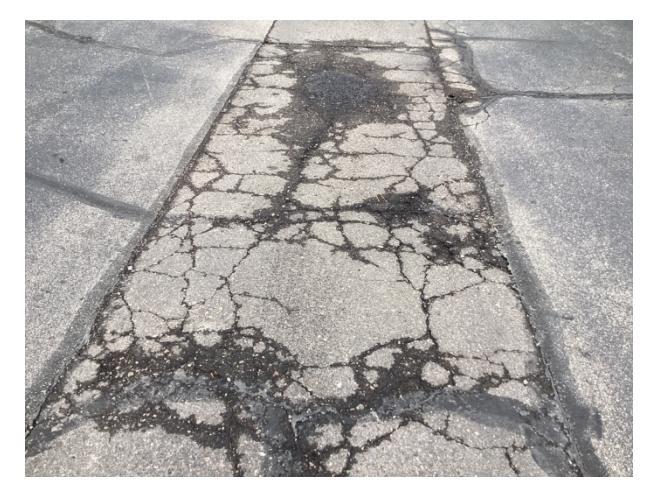
Alligator cracks along previously patched section along Bent Trail Drive

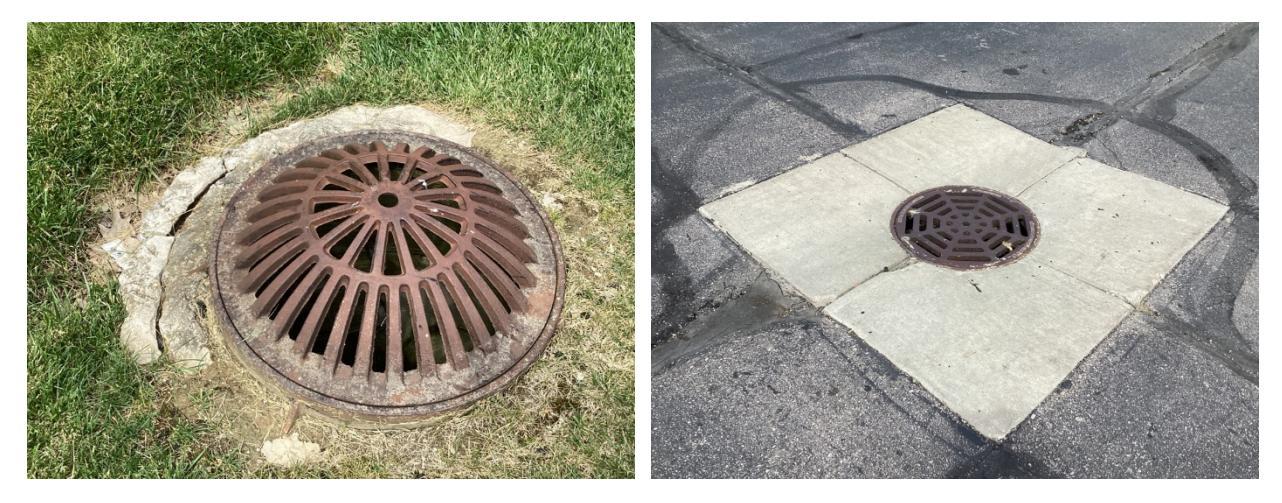
Condition: Good to fair overall with collar damage evident.

Catch basin along landscape- note collar damage

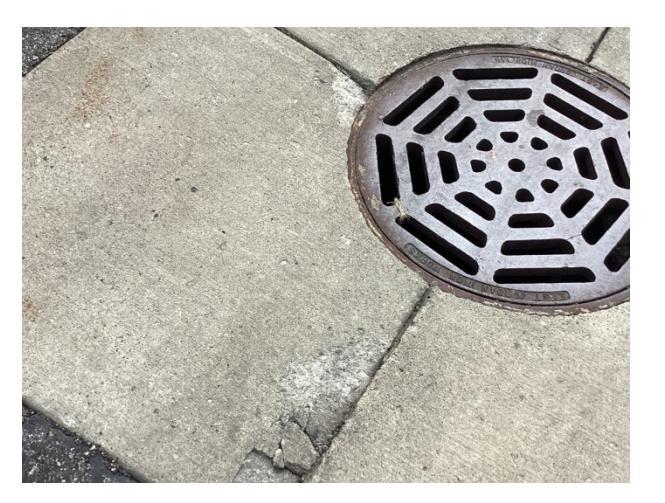
Catch basin collar damage

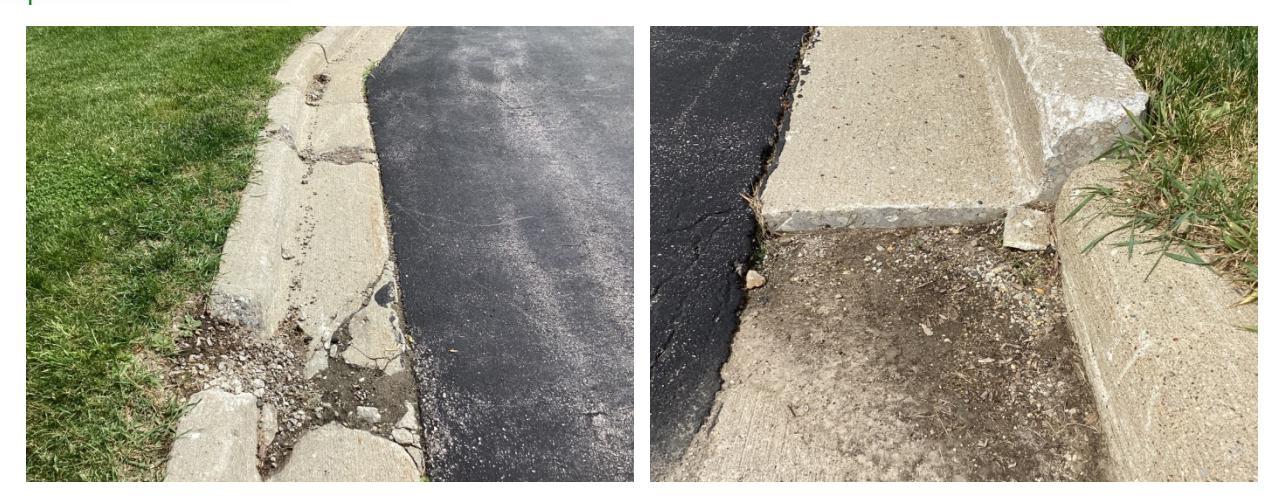
Condition: Fair overall with cracks, settlement and damage evident.

Concrete damage

Curb settlement

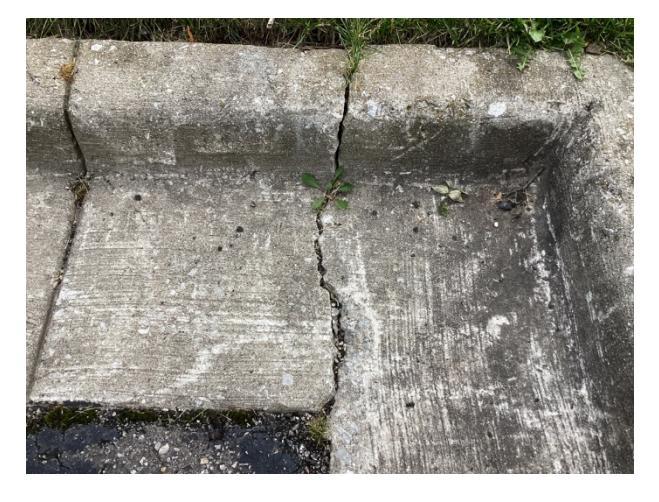
Concrete cracks

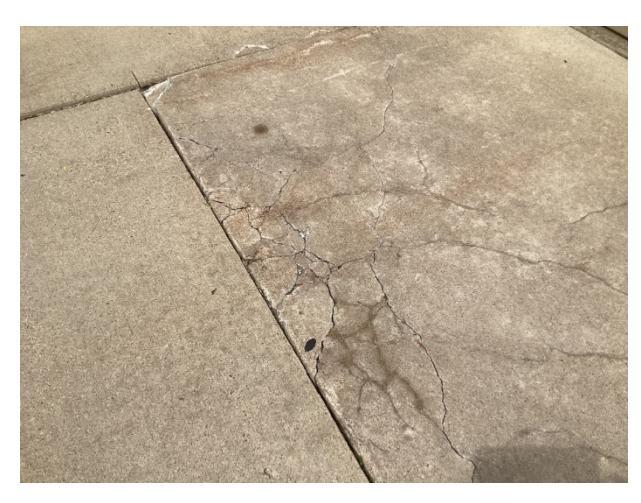
Driveway cracks

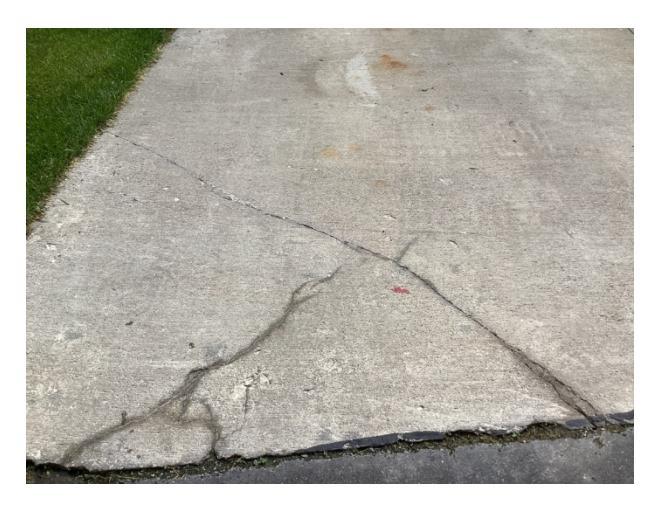
Driveway cracks

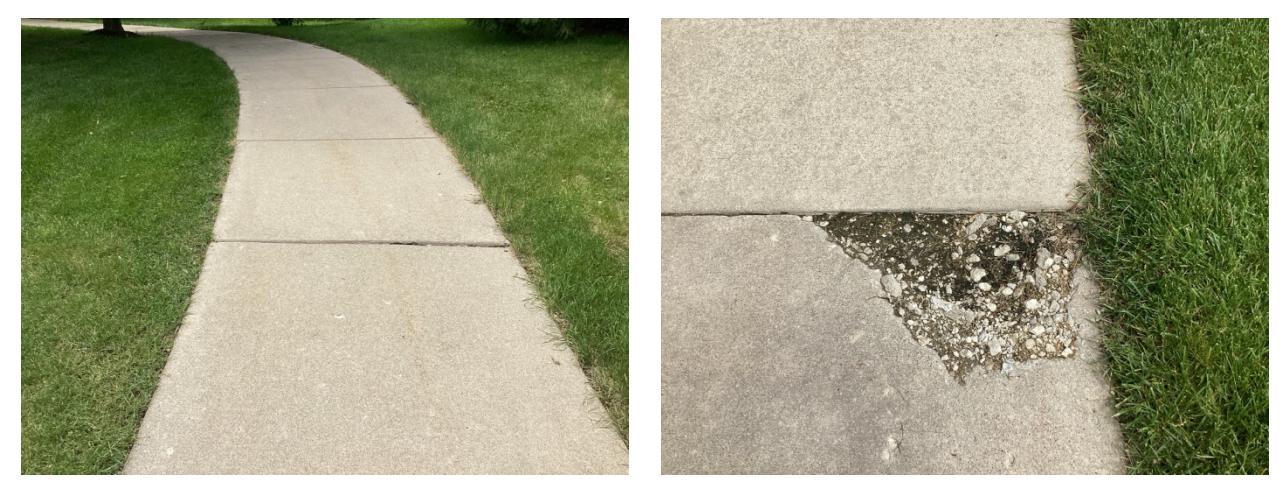
Condition: Good to fair overall. We note concrete damage and sealant deterioration between sidewalk and stoop.

Concrete damage

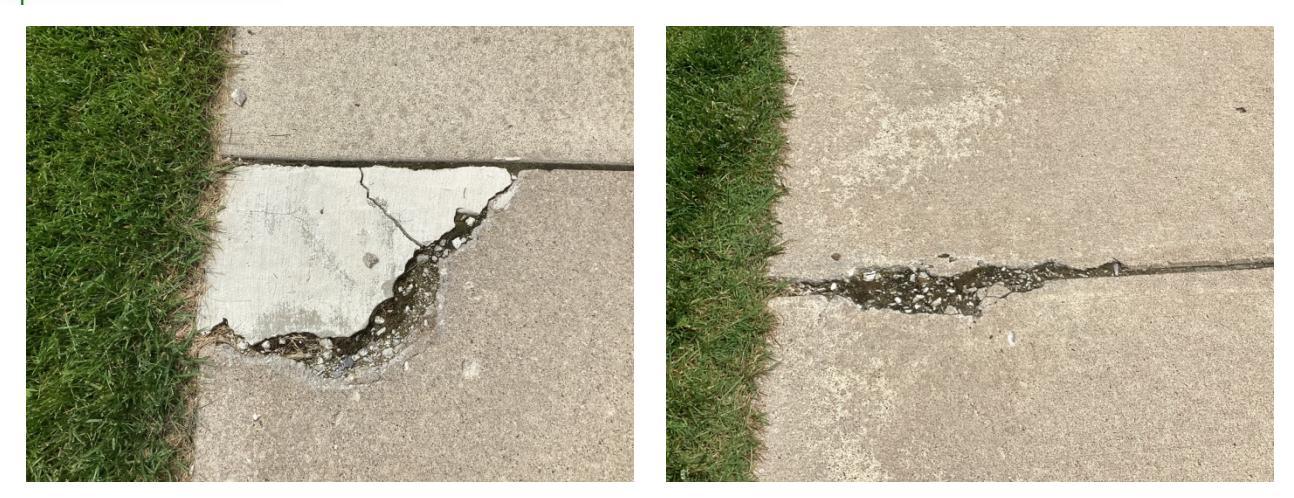
Concrete damage

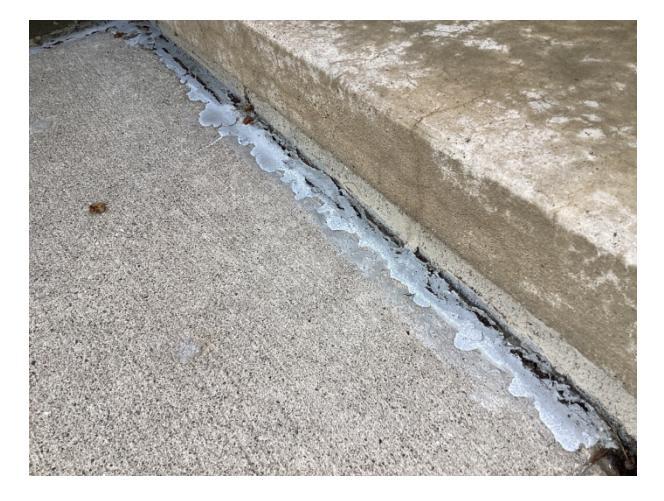
Sealant deterioration between sidewalk and stoop

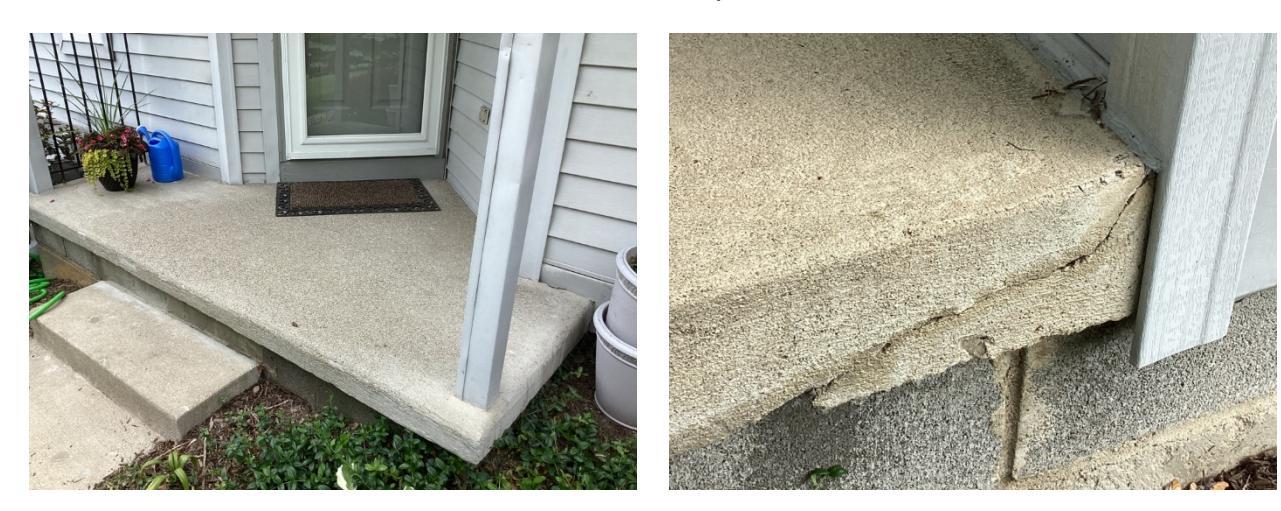
Condition: Good to fair overall with cracks and spalled concrete evident.

Stoop cracks

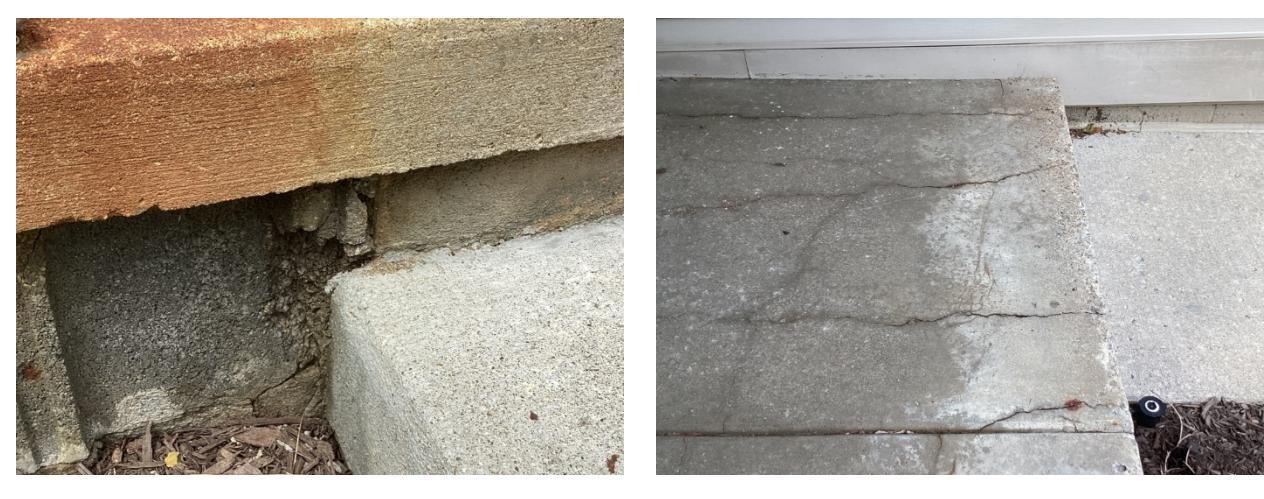
Concrete spalling

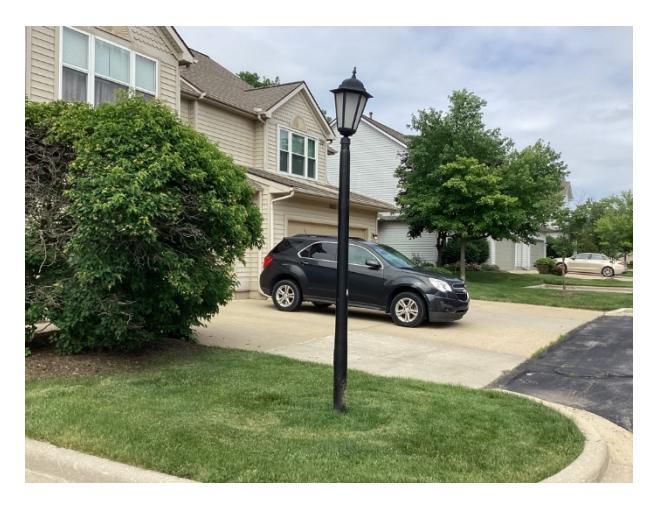
Condition: Good to fair overall with isolated fixture damage evident. We recommend the Association fund repairs through the operating budget.

Light pole and fixture - note fixture damage

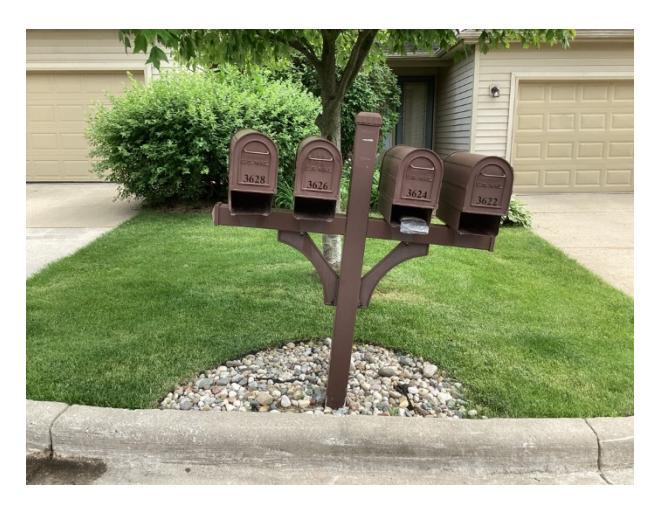
Condition: Good to fair overall with isolated post lean evident

Mailbox lean

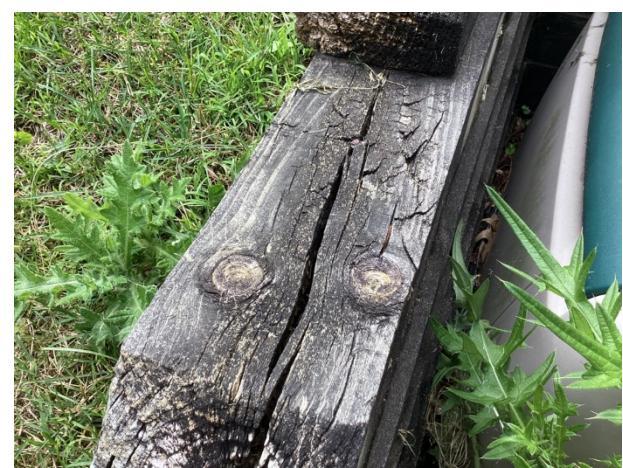
Condition: Fair overall with wood rot evident. We also note weathering of wood and damage.

Weathering of wood

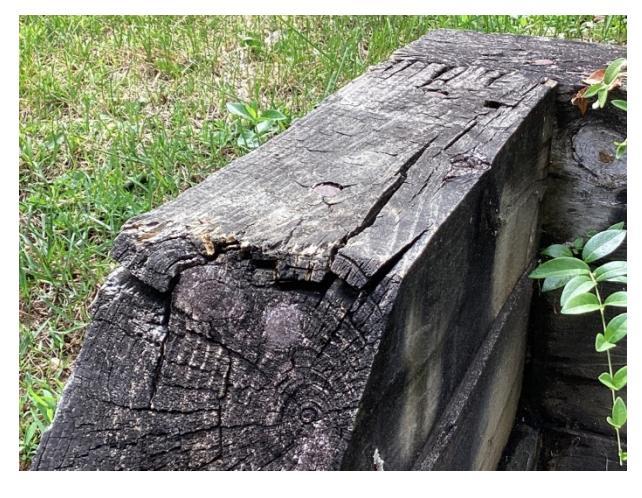
Weathering of wood

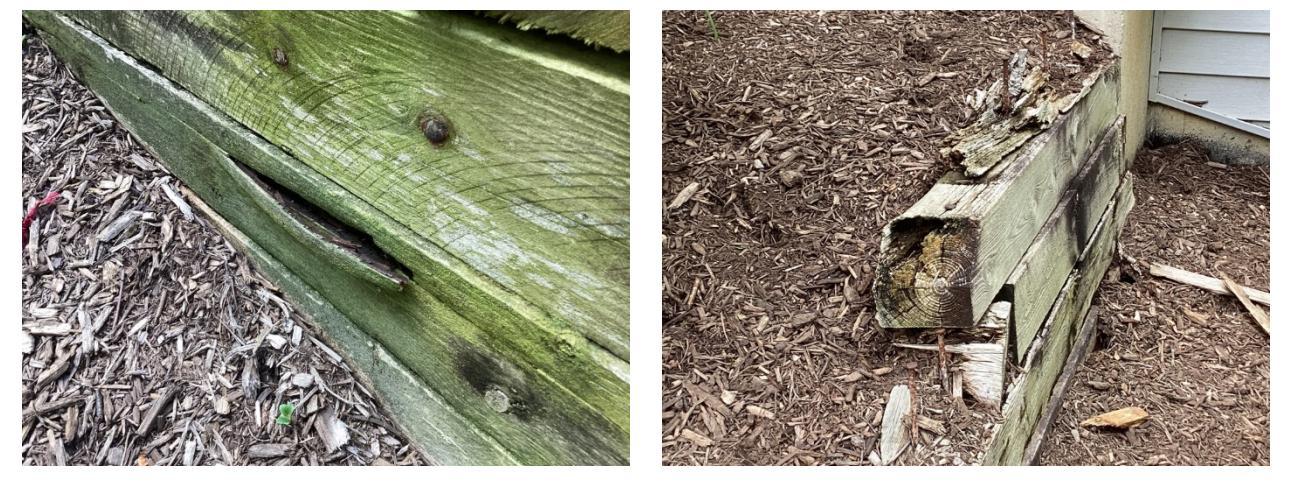
Wood damage

Wall wood rot
